Pest Report

15 Simple Street Chatswood NSW 2067

1408030

VISUAL TIMBER PEST INSPECTION REPORT as per AS4349.3-2010

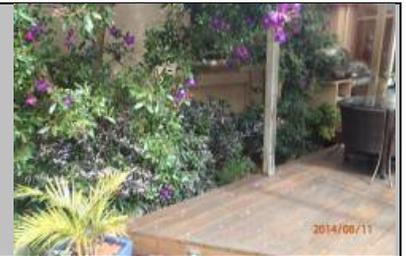
Externally:

To the walls where stored goods or foliage is present.

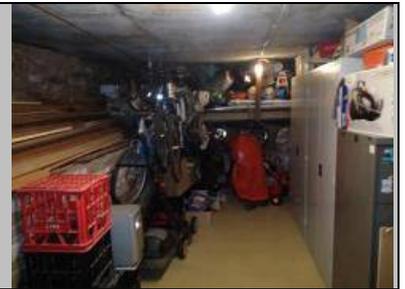
Laundry: Garage:

Fungal Decay Caused by Wood Decay Fungi found

Yes - Fungal Decay (wood rot) was noted to the following timbers/areas.

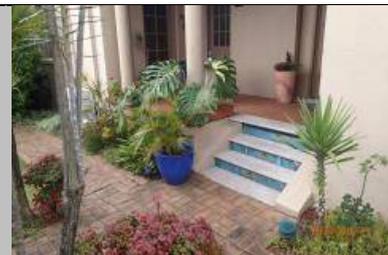
The external weep holes are either covered completely or partly concealed. This can allow concealed termite entry and we recommend that all weep holes be exposed and kept clear of soil, foliage, debris, stored items or any other obstructions.

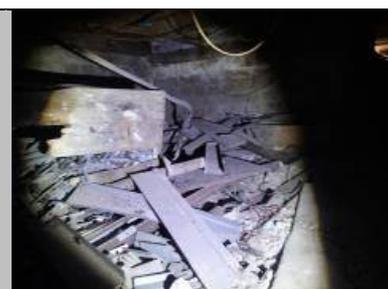
We note the general lack of ant capping. The purpose of ant capping is to reduce the risk of concealed termite attack by ensuring that termite workings are exposed and visible. Ant capping should be repaired or installed where possible. If this is not possible, regular inspections are recommended. Missing, damaged or poor termite ant capping increase the risk of termite infestation.

We recommend the removal of stored timbers from the underfloor as timbers in contact with soil are highly attractive to termite attack.

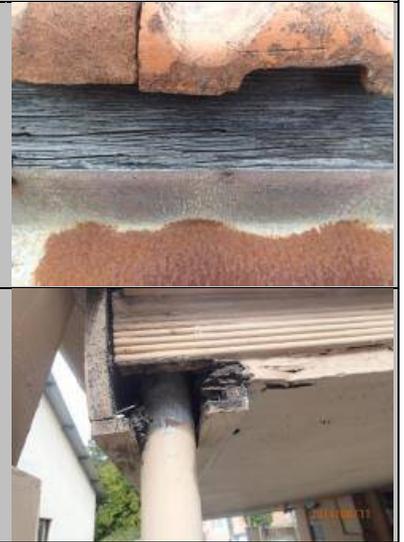
Left side of the property: Right hand side of the property: Rear section of the property: Front section of the property:

Affected external timbers

Window frames: Fascia timbers: Gable Timbers:

Visible timber damage appears minor to moderate however, we are not builders and this is not to be considered a builder's opinion. Refer to the definitions section of this report - Section 1.6 - Timber Damage.

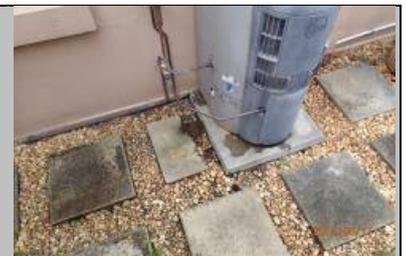
The hot water system overflow is discharging moisture adjacent to the structure. Hot water units that release water alongside or near to building walls should be piped to a drain (if not possible then several meters away from the building) as the resulting wet area is highly conducive to termites.

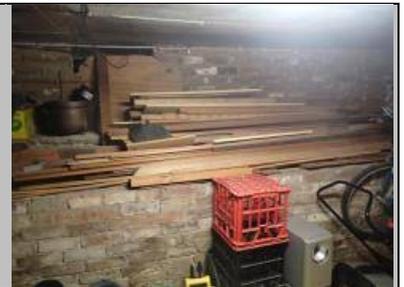
Stored items restricted inspection to the interior of the workshop.

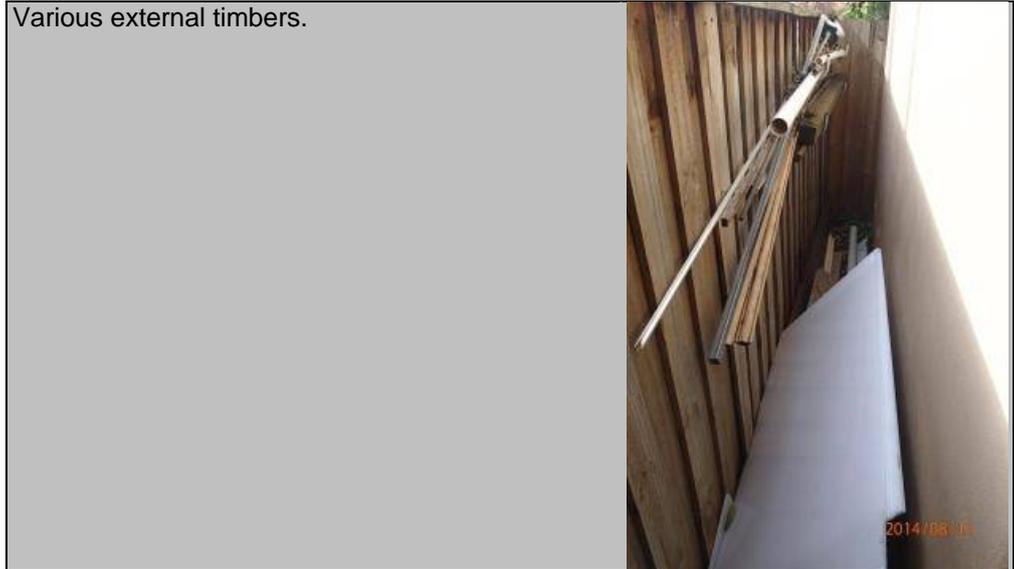
Eastern elevation.

Fungal Decay caused by Wood Decay Fungi found:

Yes - Fungal Decay (wood rot) was noted to the following timbers/areas.

Visible timber damage appears minor to moderate however, we are not builders and this is not to be considered a builder's opinion. Refer to the definitions section of this report - Section 1.6 - Timber Damage.

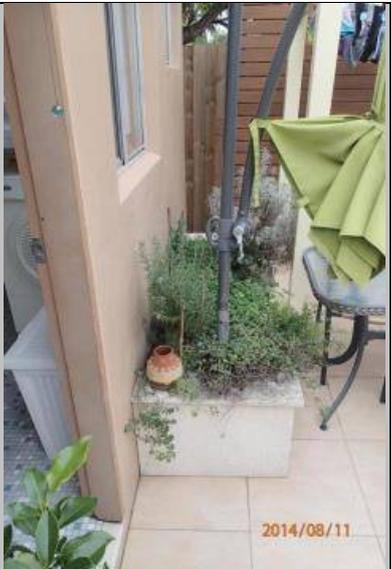
Garden beds have been built up against the external walls. These should be removed as they can allow concealed termite entry.

We recommend the removal of loose timbers from the underfloor area as these predispose the property to termite attack.

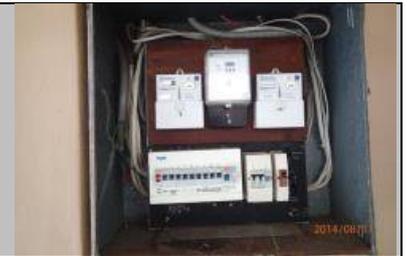
There was no visible evidence of previous termite treatment.
