# Building Report

13 Sample Place Frenchs Forest NSW.

1401234

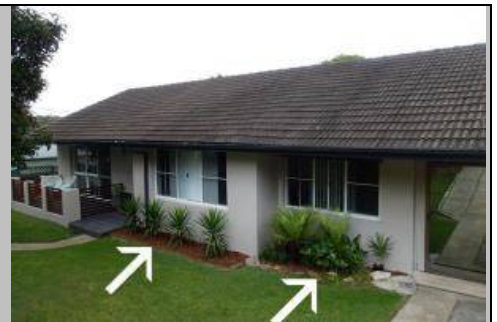
The surface water drainage at the front of the property appears to be inadequate. Drains should be installed to divert seepage and surface runoff water away from the building to prevent possible structural damage. The drains should be connected to a stormwater drainage system.
