# Building Report

XYZ Solicitors

12 Sample Road Allambie Heights NSW.

1402345

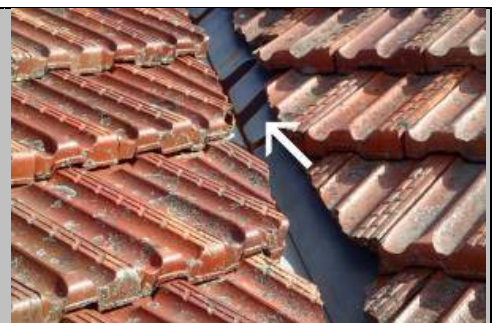
Valley metals are rusting and should be treated or replaced as required.

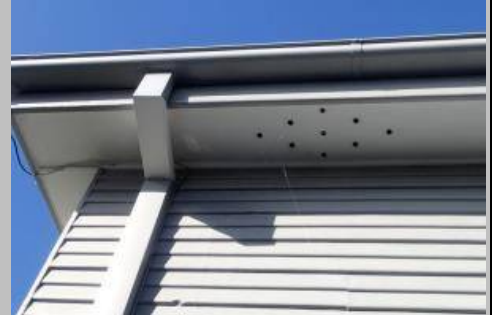
The eaves appear to be lined with asbestos fibre sheeting. Although we are not qualified in the detection of asbestos material, this item appears to contain asbestos. Asbestos material should not be disturbed or damaged and should only be removed or altered by a licensed asbestos removal contractor. Asbestos is hazardous to health and should be sealed to prevent exposure. Recommend an analysis by a qualified removal expert be conducted of these materials to confirm the amount and importance of the asbestos present, and the cost to seal or remove. The condition of the eave area is generally acceptable.

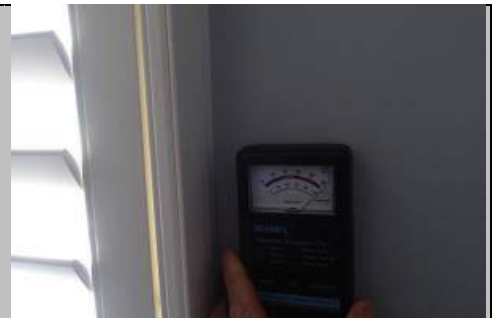
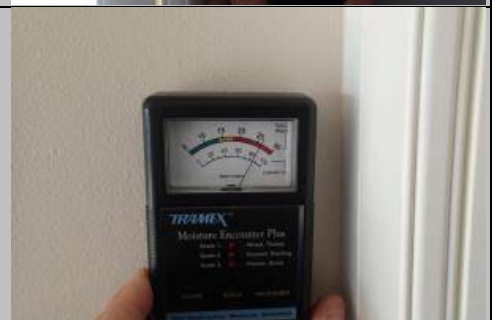
Bedroom three. Dining room.

The condition of the walls is generally acceptable. Evidence of lateral damp was noted. This may be the result of a cavity bridge, plumbing leak or other undetected defect. This situation should be rectified.

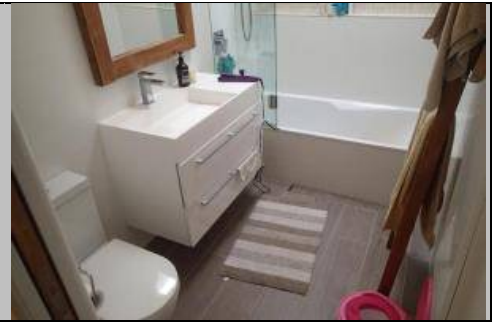
Rear.

The shower is located over the bathtub. The area will need to be kept well sealed to prevent water penetration to surrounding areas.

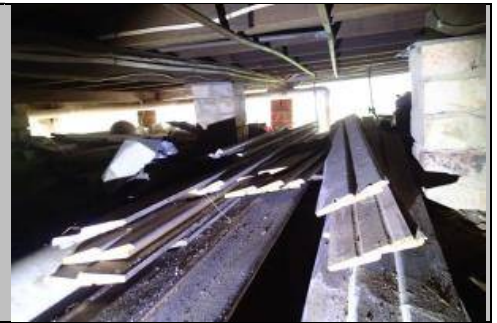
We recommend the removal of loose timbers from the underfloor area as these predispose the property to timber pest attack.

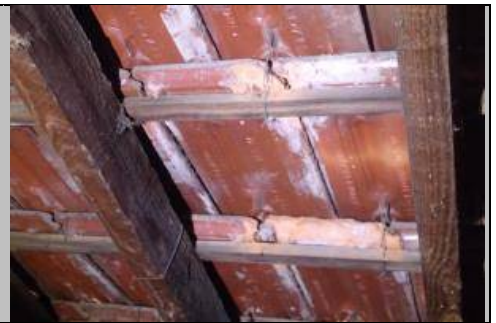
Minor fretting was noted to terracotta tiles. This will deteriorate gradually over time and replacement should be considered within 5 to 10 years. Please note: The replacement period is an estimate only. In some circumstances, fretting may be accelerated by various conditions and deterioration may occur in a shorter period of time than our estimate.

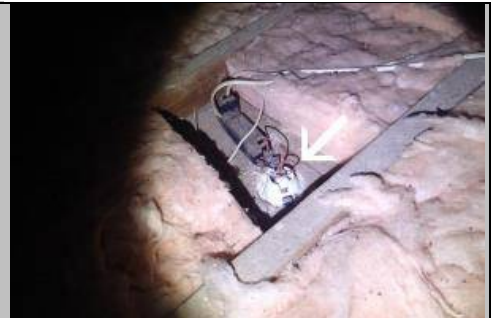
Insulation has been provided to the roof void. Insulation is covering or close to some lights and electrical fittings in the roof void. This may cause overheating and possibly a fire. Consult a licensed electrician to check on these installations and take necessary action to rectify.

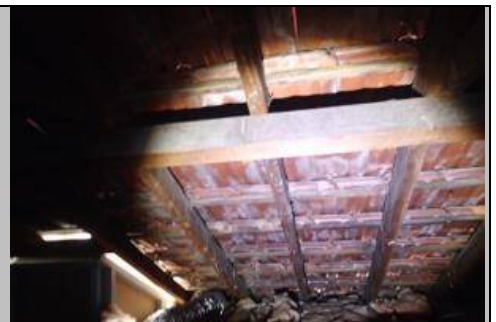
Sarking has not been provided to the roof area.

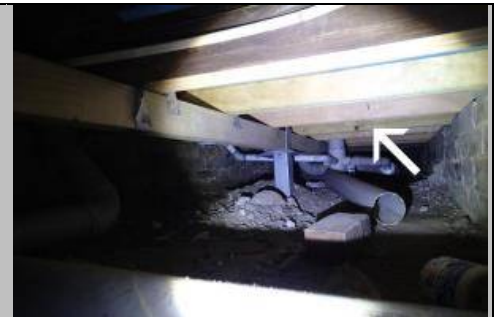
Some timbers (listed below) appear to be new or not the original timbers. We recommend if you are using this report to purchase this property, further enquiries should be made to determine the reason for timber replacement.

Bearers. Floor joist/s.

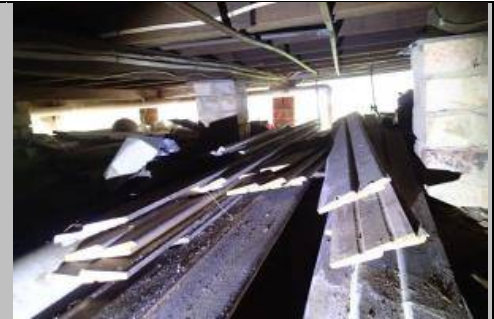
Bedroom three.

We recommend the removal of loose timbers from the underfloor area as these predispose the property to termite attack.

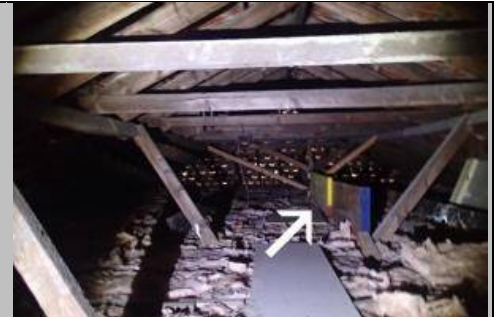
Kitchen.

Hanging beam.
