Building Report

13 Sample Place Frenchs Forest NSW.

1401234

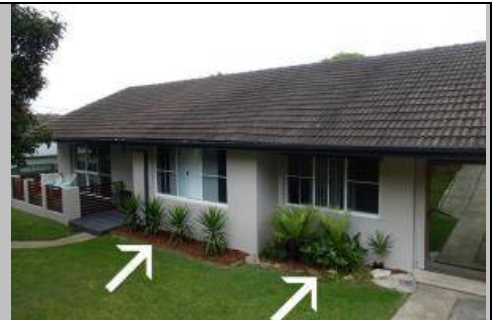
The surface water drainage at the front of the property appears to be inadequate. Drains should be installed to divert seepage and surface runoff water away from the building to prevent possible structural damage. The drains should be connected to a stormwater drainage system.

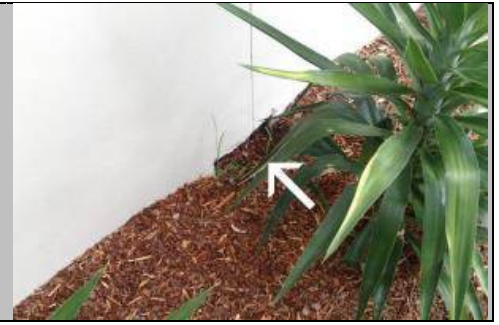
Some Vents to the base of the brick walls are partly blocked by gardens, soil or pathway heights and should be cleared to help prevent moisture and pest problems.

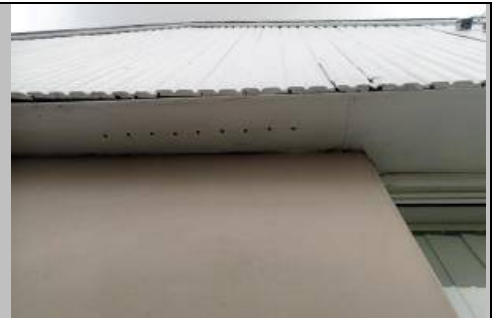
The eaves appear to be lined with fibre cement sheeting. Although we are not qualified in the detection of asbestos material, this item appears to contain asbestos. Asbestos material should not be disturbed or damaged and should only be removed or altered by a licensed asbestos removal contractor. Asbestos is hazardous to health and should be sealed to prevent exposure. Recommend an analysis by a qualified removal expert be conducted of these materials to confirm the amount and importance of the asbestos present, and the cost to seal or remove. The overall condition of the eaves lining is fair.

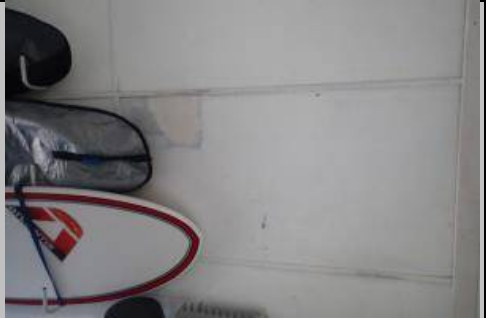
The condition of the walls is generally acceptable. Minor maintenance and or repairs required prior to next repainting.

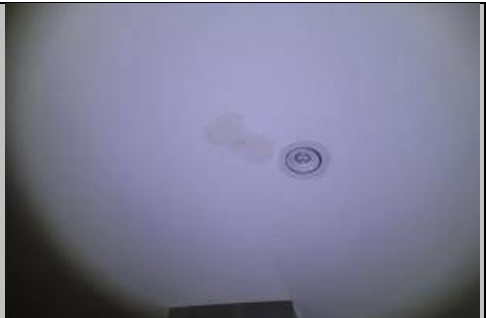
Kitchen. Bedroom two.

The condition of the ceiling area is generally acceptable. Minor maintenance and or repairs are required prior to next repainting.

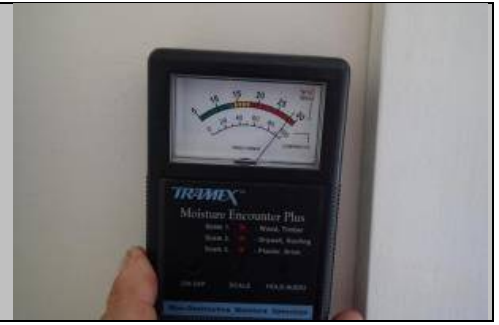
Bedroom three.

The condition of the walls is generally acceptable. Evidence of lateral damp was noted. This situation should be rectified.

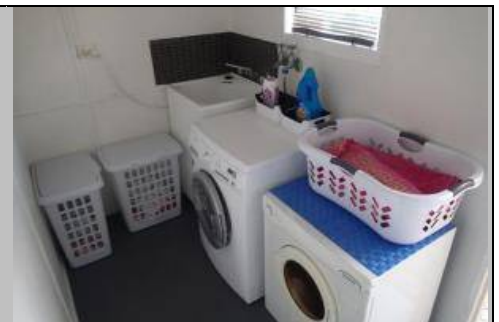
Rear.

Tap set is loose and requires securing. Drain appears serviceable.

Tiles are not present to wet areas. Recommend tiles be installed to prevent water penetration.

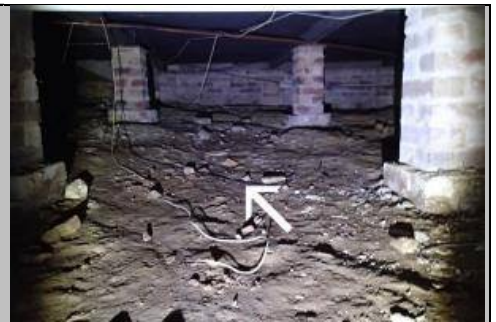
The underfloor soil is damp. This may be due to a drainage problem or some other factor. This area should be monitored to determine a cause for the dampness and the problem rectified.

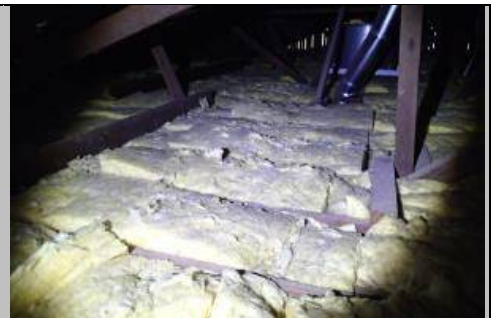
Insulation is present in the roof cavity. This restricted inspection to some roofing timbers. Removal of insulation is not within the scope of a standard visual inspection report.

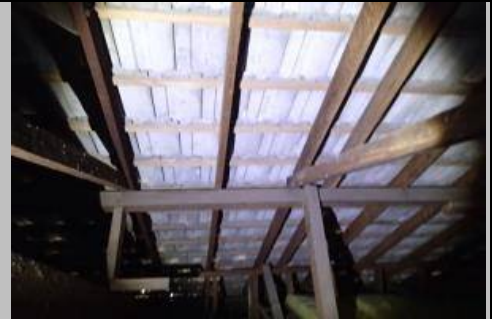
Sarking has not been provided to the roof area.

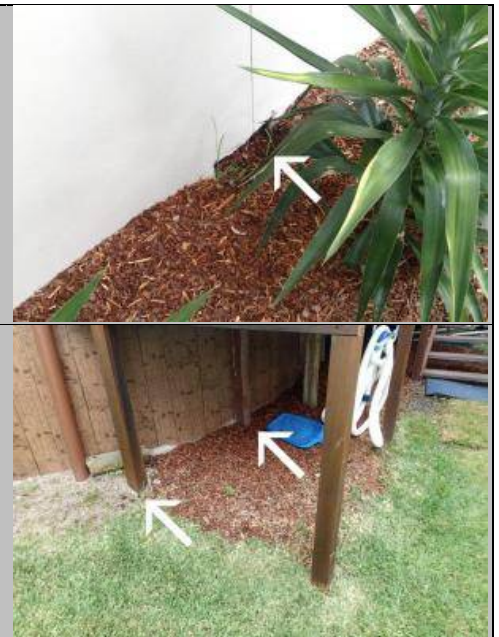
The external vents/weep holes are either covered completely or partly concealed. This can allow concealed termite entry and we recommend that all vents/weep holes be exposed and kept clear of soil, foliage, debris, stored items or other obstructions. Some external timbers are in contact with soil. These should be modified so that timber to soil contact does not occur.
